PIGTAIL CATHETER INSERTION ERROR: ROOT CAUSE ANALYSIS AND RECOMMENDATIONS FOR PATIENT SAFETY

Joshua S. Broder, MD,* Bahaadin Al-Jarani, MD,* Brenda Lanan, MD,* and Kelli Brooks, MD†

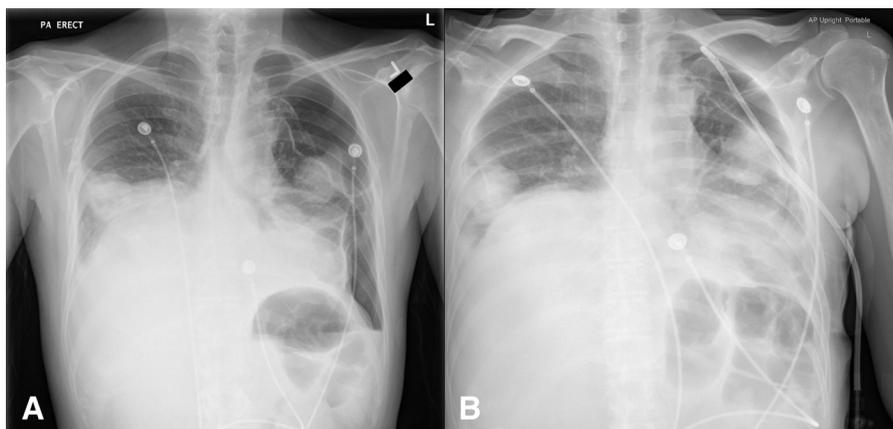
A 43-year-old man with sarcoma presented with dyspnea. Chest x-ray study (Figure 1A) demonstrated left pneumothorax and metastatic disease. The patient's respiratory distress worsened, and a 14.0-Fr catheter (Wayne Pneumothorax Tray, Cook Medical, Bloomington, IN) was placed (Figure 1B). A series of chest x-ray studies were obtained due to unresolved symptoms, each showing residual pneumothorax. Chest computed tomography (CT) confirmed the catheter position in the pleural space (Figure 2A). Ultimately, the catheter obturator, used to stiffen and straighten the catheter for insertion, was found not to have been removed as intended. The obturator was then removed, but the function of the catheter could not be restored, and a larger thoracostomy tube was placed. The error was reported through the institution's electronic safety reporting system and disclosed to the patient's family.

Figure 1. Clues to retained catheter obturator. (A) Initial chest radiograph. A left pneumothorax is present. (B) A 14.0-Fr pigtail catheter (Wayne Pneumothorax Tray; Cook Medical, Bloomington, IN) has been inserted. Several radiographic clues exist to indicate that the catheter is not correctly inserted. These are examined in subsequent figures. The catheter does not have the expected “pigtail” curved shape at its tip, but rather is straight. The obturator is visible within the intrathoracic portion of the catheter and extends out of the extracorporeal portion.

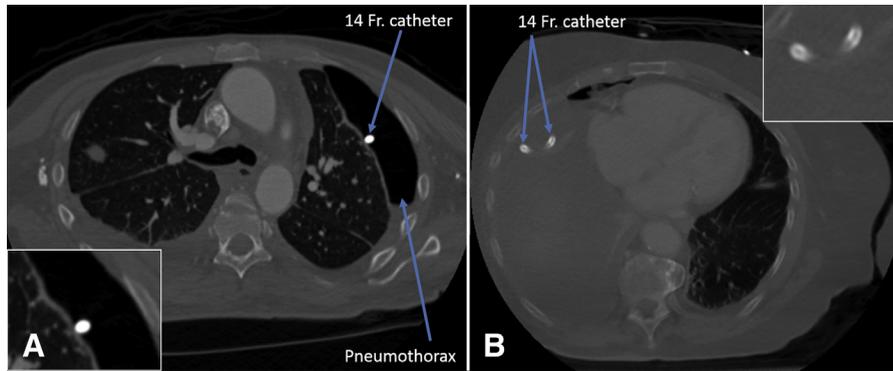
Figure 2. Computed tomography appearance. (A) At left, patient with retained catheter obturator. The 14.0-Fr catheter is visible in cross section, within the pleural space. A pneumothorax is visible. Of note, the catheter appears solid (inset, lower left), not hollow, even on window settings that typically highlight air—another indication that the obturator remains in place. **(B)** A different patient, with the same catheter type inserted, without the obturator. The catheter tip is curled as expected and also appears hollow (see inset, enlarged, upper right). Both images are depicted with bone windows (C570/W3077).

On chest CT, the abnormally straight appearance of the catheter is evident on scout images (Figure 4) when the obturator is in place. On planar cross-sectional CT images, the catheter appears solid with the obturator in place, rather than having an expected air-filled channel (Figure 2). CT also demonstrates whether the catheter is appropriately located in the pleural space.

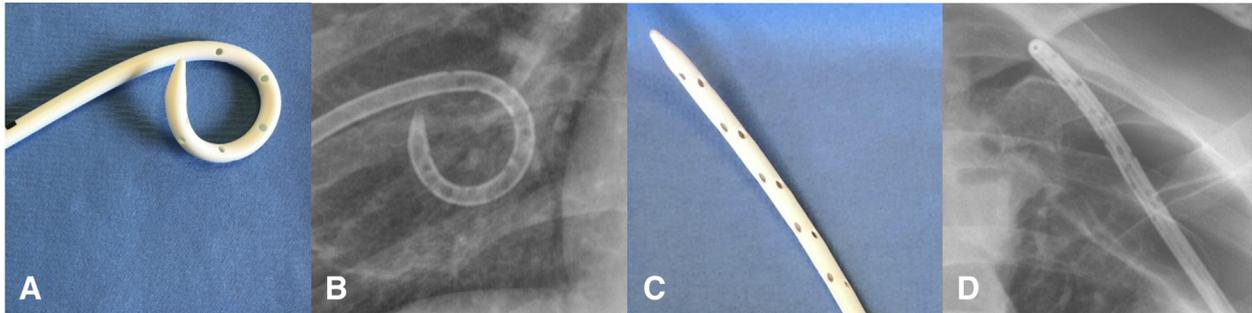
We identified several radiographic features of retained catheter obturator (Figures 1–4). The expected appearance of the pigtail catheter on chest radiograph is its namesake: a curled configuration resembling a pig’s tail (Figures 2–4). With the catheter obturator in place, the catheter has an unexpectedly straight appearance (Figures 1, 3, 4). In addition, the obturator is radiographically visible, creating a “tube within a tube” appearance on chest radiograph (Figure 3). When the obturator is removed as intended, this radiographic finding is not evident (Figure 3).

Figure 3. Physical and radiographic appearances of catheter, correct and incorrect. (A) Photograph, *without* the stiffening obturator in place. The catheter tip assumes its namesake “pigtail” shape. (B) Radiographic appearance, *without* the stiffening obturator device in place. The “pigtail” shape is visible. The catheter appears hollow [compare with (D)]. (C) Appearance with stylet in place (straight). The pigtail shape is absent. (D) Radiographic appearance with the stiffening obturator in place. The catheter appears unexpectedly straight. A “tube within a tube” appearance is present, because the obturator fills the normal lumen of the 14.0-Fr catheter [compare with (B)].

Additional systematic improvements for radiographic detection could be implemented. Images of the expected and incorrect radiographic appearances could be included in the kit to guide the user. Given the large number of catheters in clinical use, a radiologist not informed of the specific device may not recognize the absence of the expected pigtail radiographic configuration. Communication with the radiologist to identify the specific catheter placed could enable the radiologist to recognize an unexpected appearance. The device could also be printed with radiographically visible, unique identifiers to guide clinicians and radiologists.

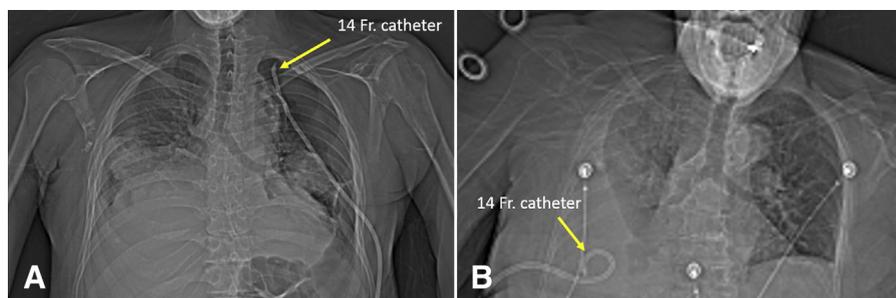
Figure 4. (A) Computed tomography scout image from patient 1 shows a straight catheter tip, an indication that the catheter obturator remains in place. (B) A different patient, with the 14-Fr catheter correctly inserted without the catheter obturator in place, shows the expected curled “pigtail” shape.

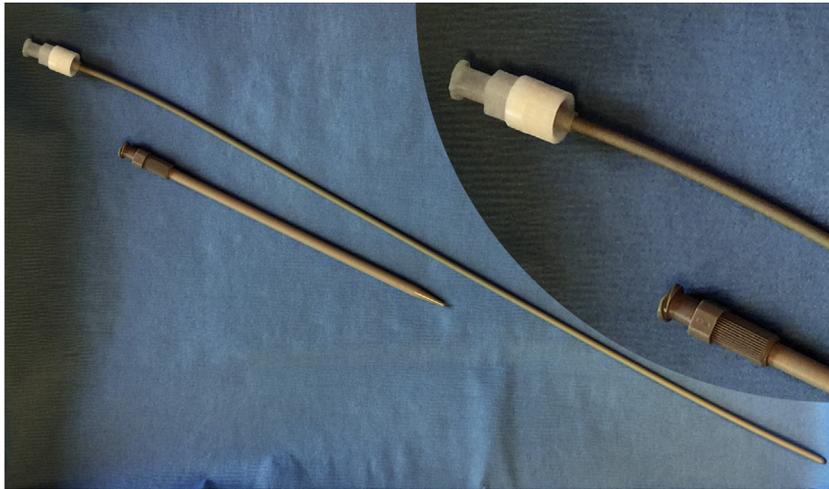
Figure 5. Luer-lock connectors on the catheter obturator and tissue dilator serve no essential purpose, but create a risk of the error observed in this case. The external drainage tube can be inadvertently connected to these devices, rather than to the 14-French catheter.

principles because the obturator unnecessarily has a Luer lock connector that is compatible with drainage tubing, enabling an operator to commit the error of connecting these two components, rather than forcing removal of the obturator prior to drainage tube connection (Figure 5). This Luer lock connector serves no essential purpose in the kit and could be eliminated, preventing

the error. The tissue dilator has an identical unnecessary Luer lock connector.

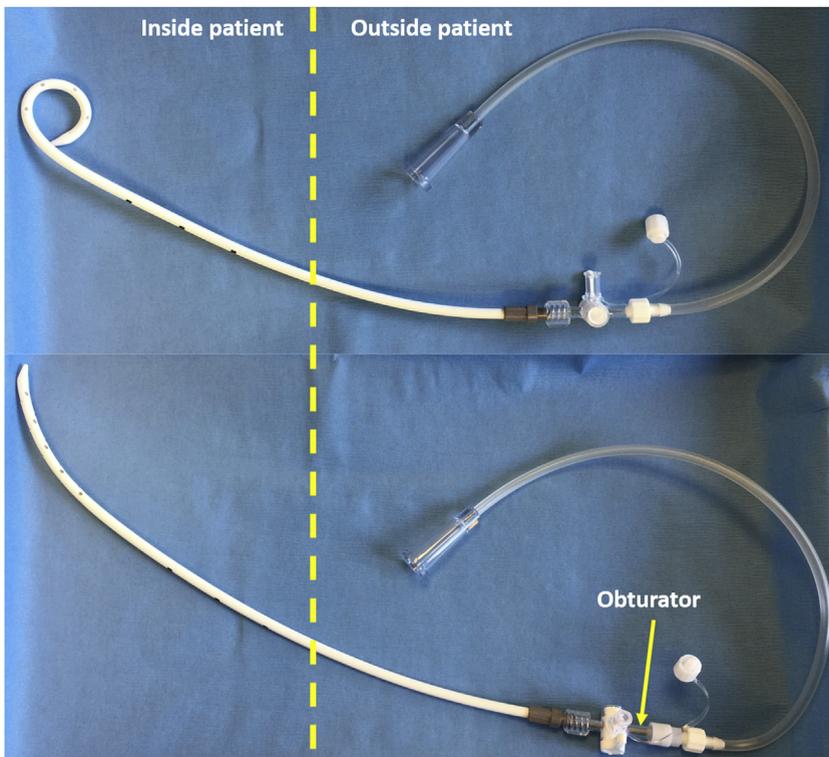
Figure 6. The assembled catheter and external drain tubing, without the obturator (top) and with the obturator (bottom). The portion of the assembly outside the patient appears nearly identical, as the obturator is an inconspicuous gray color and is hidden within the catheter.

“Visibility of system state” is essential for safety in medical devices, but violated in the kit described (10). The obturator is inconspicuous when in place within the catheter (Figure 6). This facilitates operator error, as an operator may not notice that the obturator has not been

removed. Both the obturator and the tissue dilator are an inconspicuous gray color; attention could be called to these devices with a warning hue to indicate that they should be removed or discarded. The obturator could be made more radiographically apparent to increase the likelihood that it would be recognized by a radiologist or clinician if inadvertently left in place.

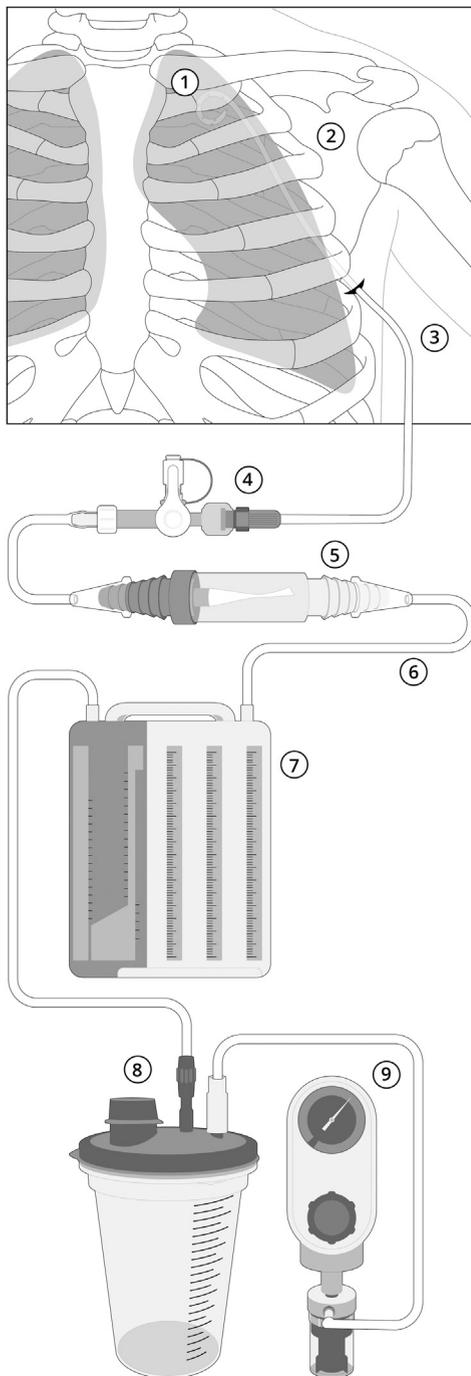
Figure 7. A systematic approach to troubleshooting chest tubes. Attribution: Illustrated by Megan Llewellyn, MSMI, CMI; copyright Duke University 2019; with permission under a CC BY-ND 4.0 license. megan.llewellyn@duke.edu

A systematic approach to the assessment of chest tube malfunction might have enabled more rapid detection and resolution of the error (Figure 7).
